# Geological Survey of Victoria

## ENGINEERING GEOLOGICAL INVESTIGATION OF PROPOSED CEMETERY SITE AT MELTON

UNPUBLISHED REPORT 1984/77

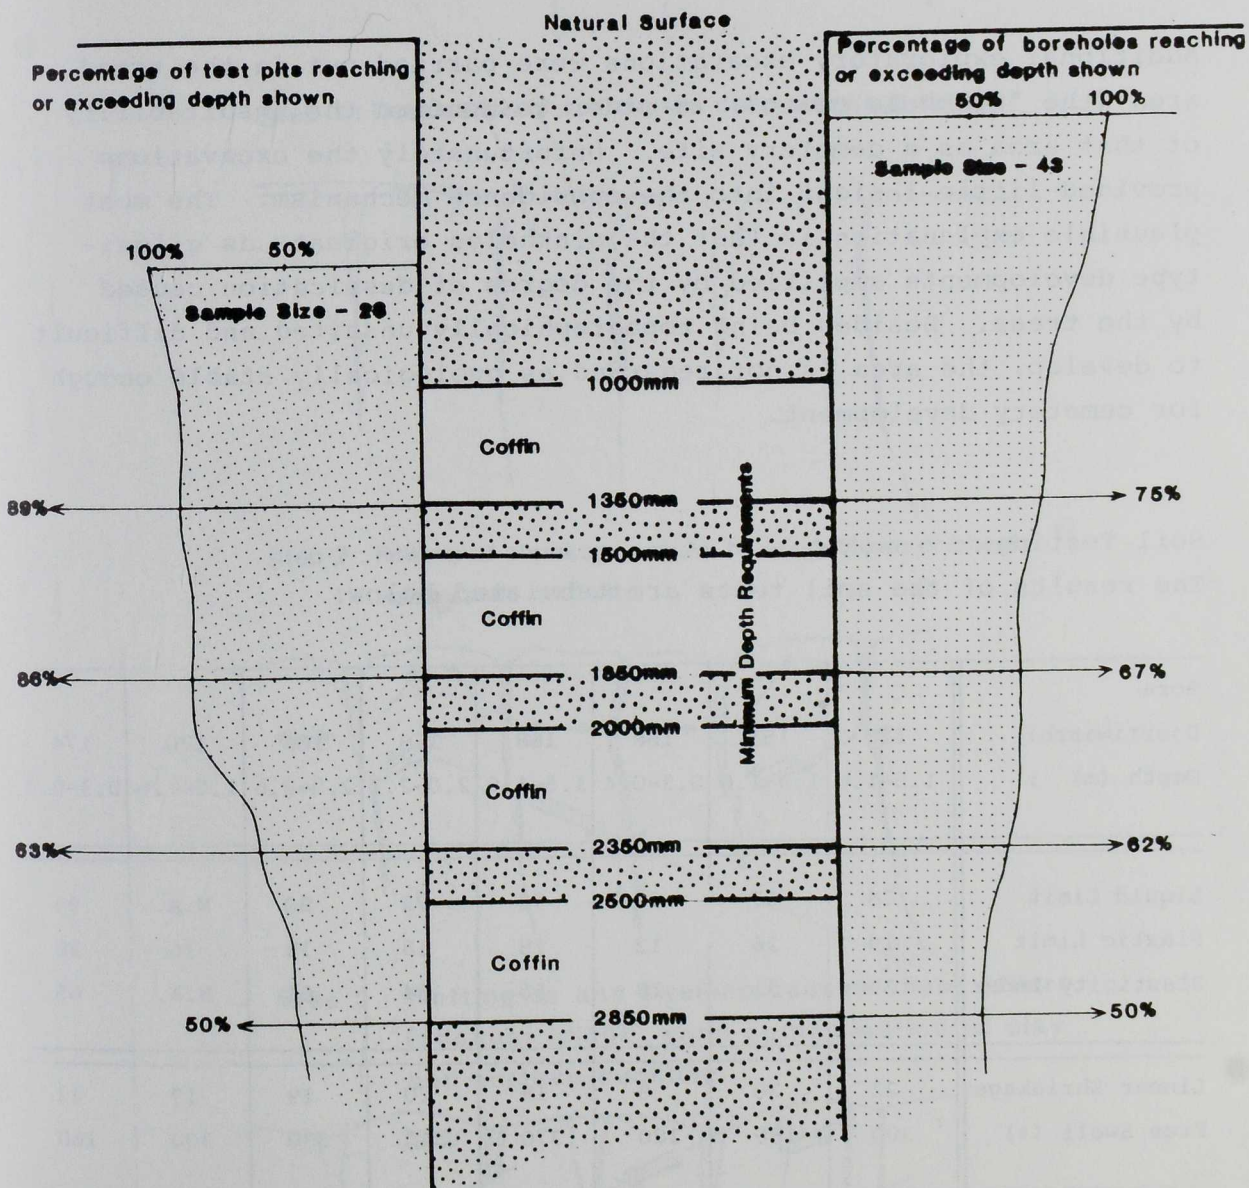
The trial excavations showed that the backhoe was easily able to excavate to three metres in 14 locations and to the minimum required depth (1.4 metres) in 25 locations. This is shown graphically in figure 2, which indicates that 89% of the test pits reached the minimum depth requirement for the burial of one coffin.

FIGURE 2. Minimum Requirements for Burial and percentage of test sites achieving the depths shown.

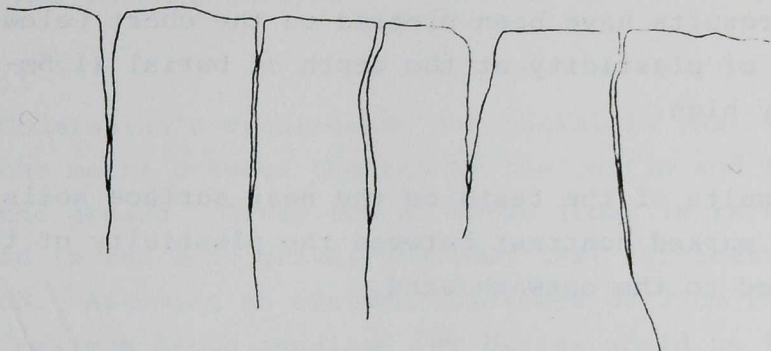
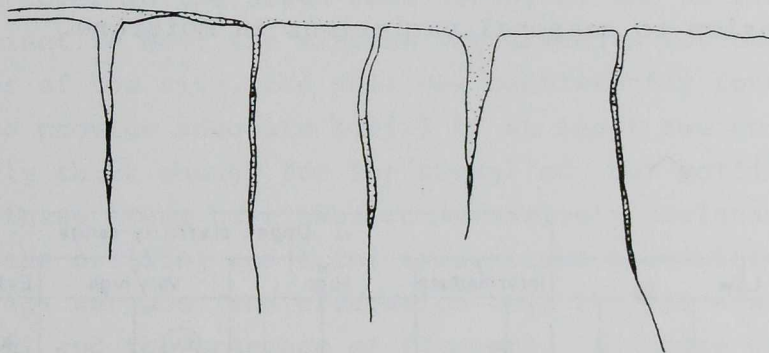
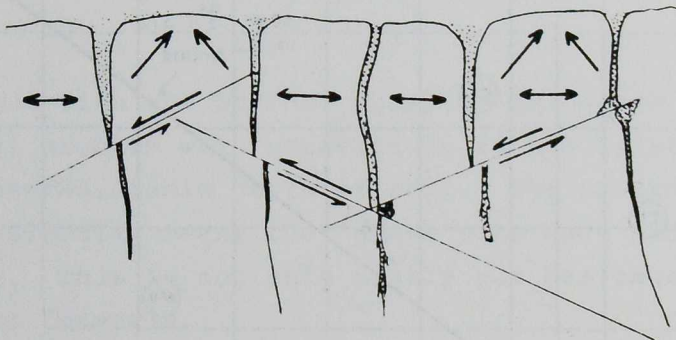
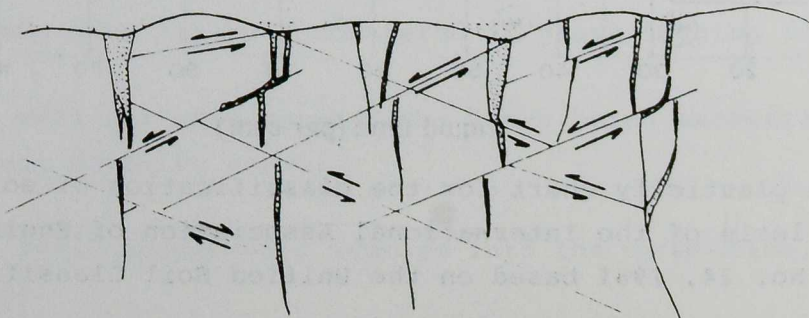
FIGURE 3. Steps in the development of the soil profile of the site.

pressures developed in expansive clays. Some fissures are infilled with very fine quartz sand, which is presumably windblown sand deposited in surface desiccation cracks formed in drier seasons. The subsequent swelling of the clays not only caused shear failure, but the assimilation of the quartz sand into the basaltic clay soil. This mechanism also causes the broad gilgai relief on the surface (figure 3).

Step 1 : Dessication of soil causes deep shrinkage cracks.

Step 2 : Infilling of shrinkage cracks by wind-blown or sheet-wash sands and silts

Step 3 : Wetting up and swelling causes shear failure (slickensiding) , sand contamination of clay and surface buckling.

Step 4 : Cyclic repetition of shrinkage and swelling produces fissures , joints , sand contamination and surface undulation .

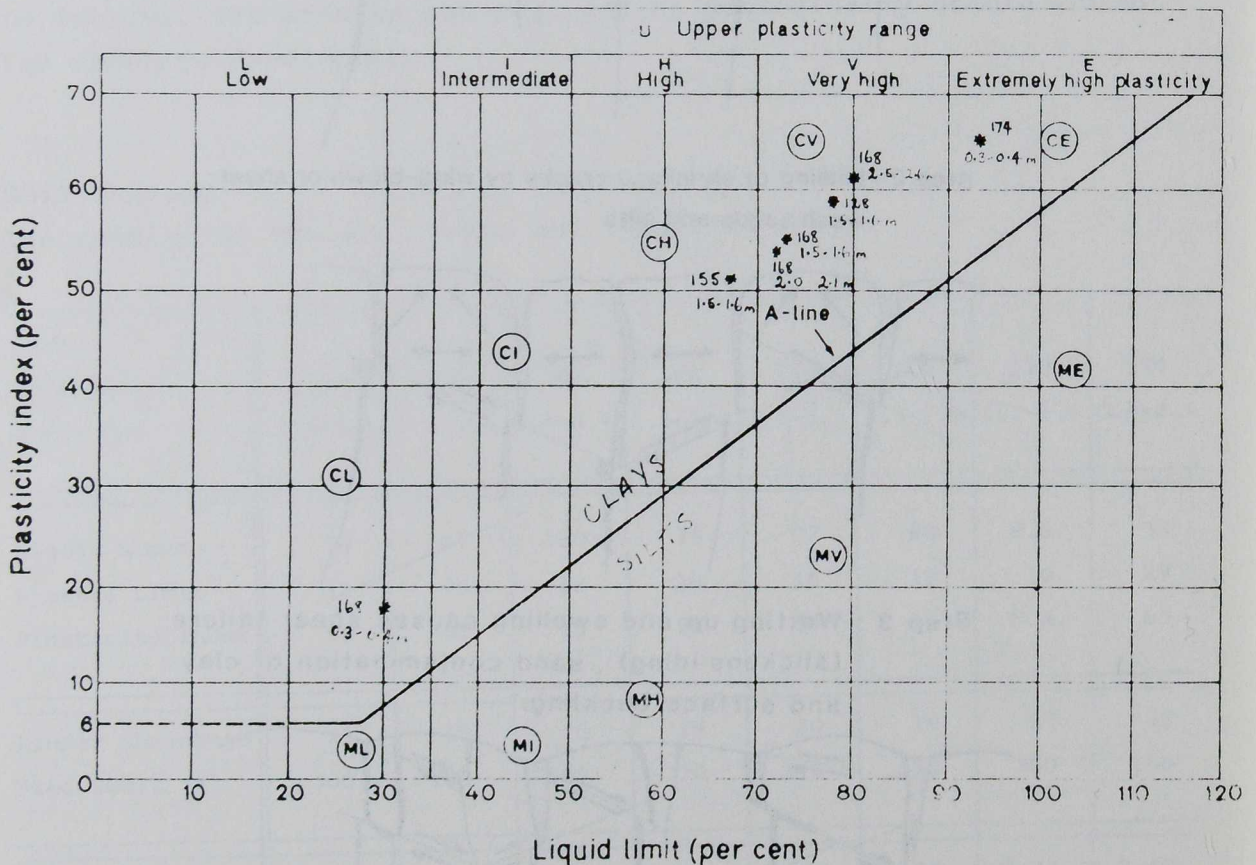
These results have been plotted on the chart below and show the degree of plasticity at the depth of burial (1.5m-2.6m) to be high to very high.

The high values for the liquid limit, plasticity index, linear shrinkage and free swell indicate that the soil is highly expansive and responsive to seasonal variations in moisture.

Fig 5 The plasticity chart for the classification of soils: (From: Bulletin of the International Association of Engineering Geology - No. 24, 1981 based on the Unified Soil Classification System).

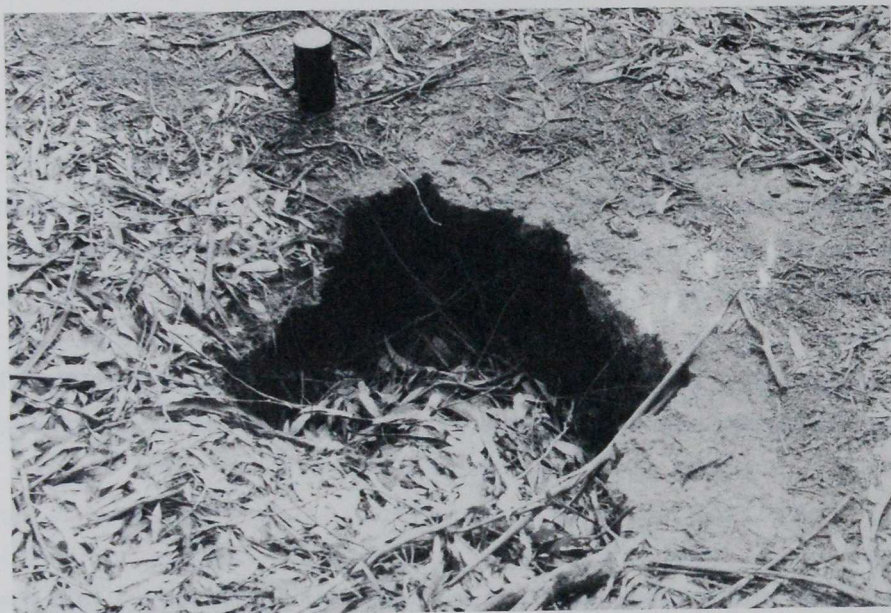
On the sink-hole plain in the north-western quarter of the site, the soil surface is affected by apparent subsidence. Although the mechanism of the subsidence remains unknown, it has been observed to be still active. Since early 1983 several new "sink-holes" have been observed to subside in the treed area and in the road reserve. Several theories have been suggested to account for their origin, however none provide a complete explanation. The most likely interpretation is that they are an extension of the gilgai process. These features are shown in plates 1 & 2.

Plate 1 Recent Subsidence in the 'Sinkhole Plain'

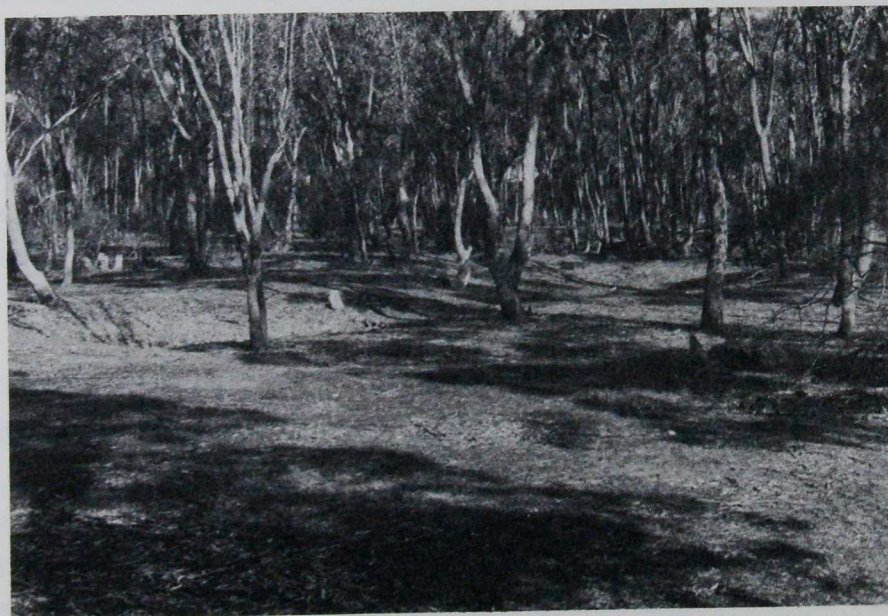
Additional exploratory excavations were carried out in the treed area (the "sinkhole plain") in order to confirm the unsuitability of that area as a cemetery site. Unfortunately the excavations provided little insight into the subsidence mechanism. The most plausible explanation is that the sinkholes originate as gilgai-type developments amplified by the degree of desiccation caused by the trees. Besides being topographically unsuited and difficult to develop, the area is not regarded as geologically stable enough for cemetery development.

Plate 2 Old Subsidence features in the sinkhole plain

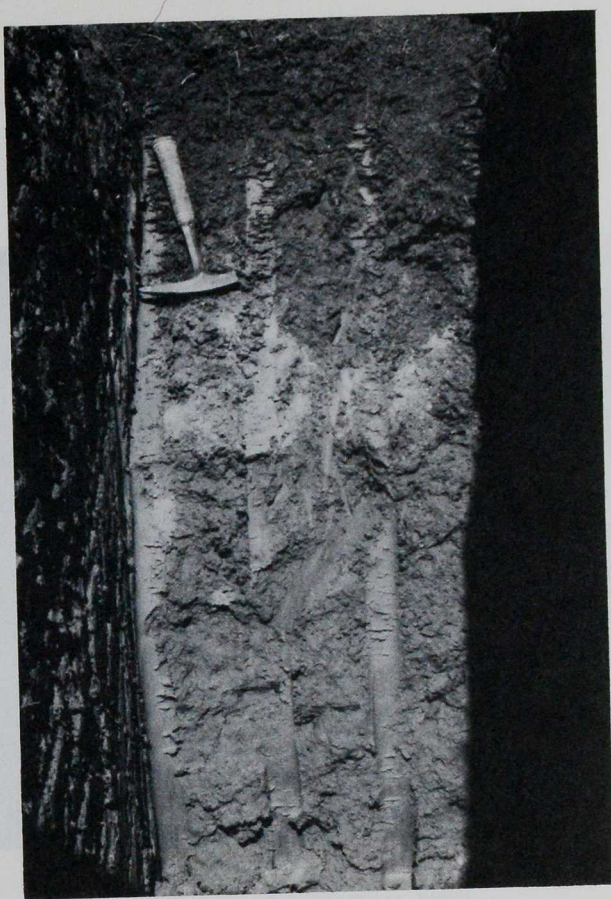
Subsoil : Yellow-brown, grey or mottled clays or sandy clays, highly plastic, stiff, fissured with occasional basalt floaters and calcareous nodules throughout.  
(plate 3)

Plate 3 Typical soil profile exposed in a test pit

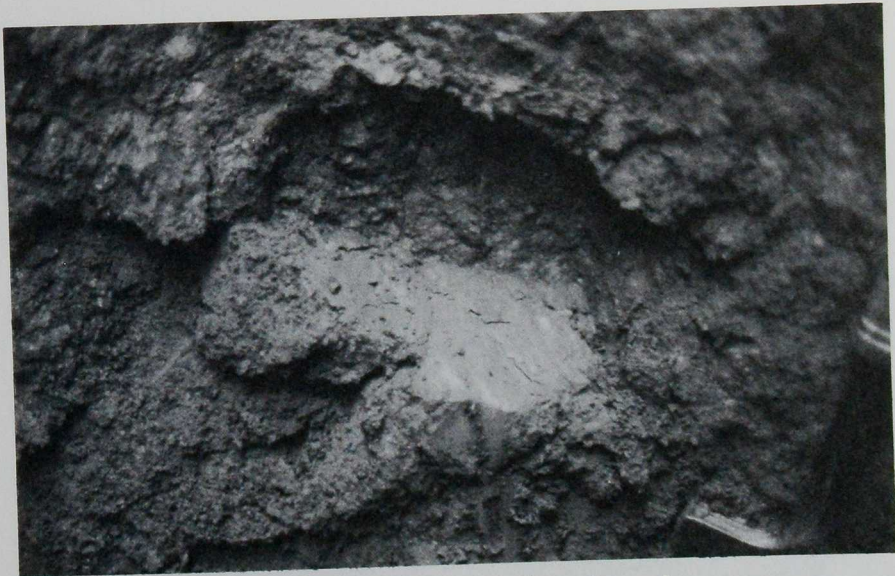
Soils observed in the test pits at the depth of burial were clays, silty clays and sandy clays of high plasticity (Appendix 2). These are often jointed, sometimes fissured, with slickensided fracture surfaces very common (Plate 4). The slickensides are caused by shear failure and movement of the soil due to swelling

Plate 4 Slickenside surface in the clay

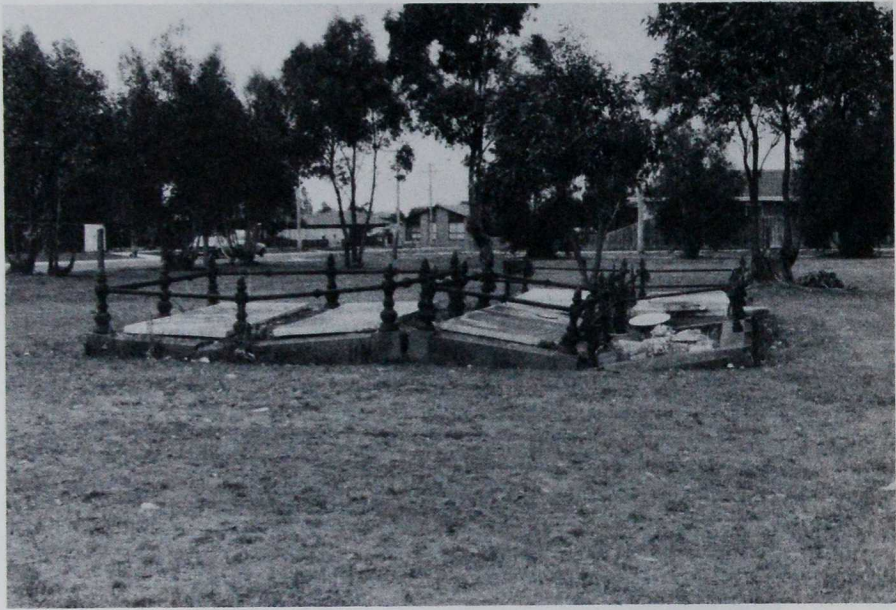
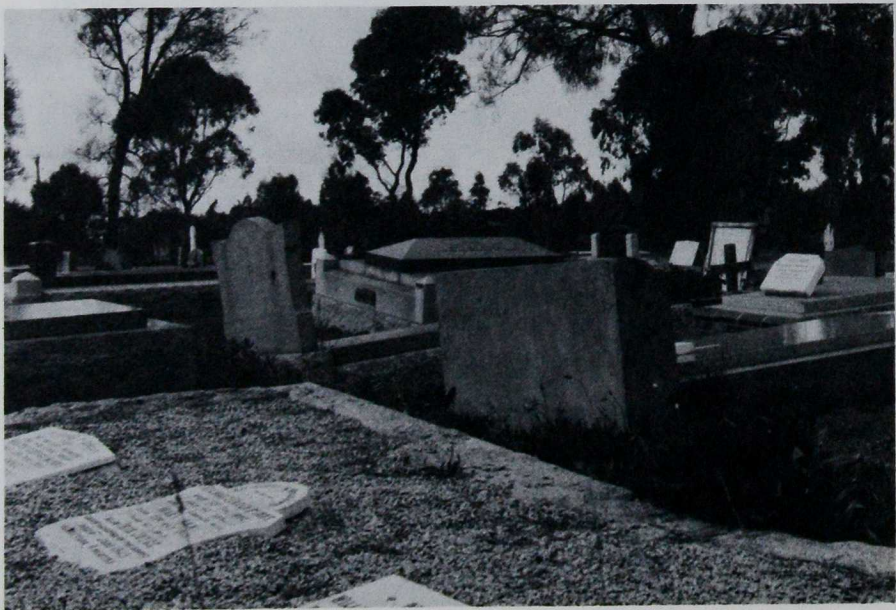
A major problem facing the development of the site as a cemetery is the expansive nature of the soils. The perpetual seasonal cycle of shrink and swell sustains the mechanism which is thought to be responsible for the subsidence in the sinkhole plain. Similarly, this also seems the most likely explanation for the observed tilting of the monuments at the existing Melton cemetery (Plates 5 & 6). After a grave is backfilled with clay, the lower density of the backfill allows easier ingress of air and water, which amplifies the seasonal movement at depth. This combined with the selfmulching nature of the clay, provides a plausible explanation of

the observed subsidence over the graves and the dramatic tilting of the tombstones. (Plates 5 & 6)

Plates 5 & 6 Tilting of Monuments at Melton Cemetery

\* Where large or high monuments are erected the sites should be levelled (by filling where necessary) and compacted. A suitably designed, wide concrete footing would help prevent the severe tilting.

\* Trees will quickly dessicate the soil and should not be planted within 10 metres of any structure, including the monuments. Where this is unavoidable regular watering should be carried out, especially in dry seasons in order to minimize the damage caused by soil shrinkage.
