AN ENGINEERING GEOLOGICAL INVESTIGATION  
OF THE URBAN LAND AUTHORITY'S PROPERTY,  
MELTON

P G DAHLHAUS

UNPUBLISHED REPORT 1985/50

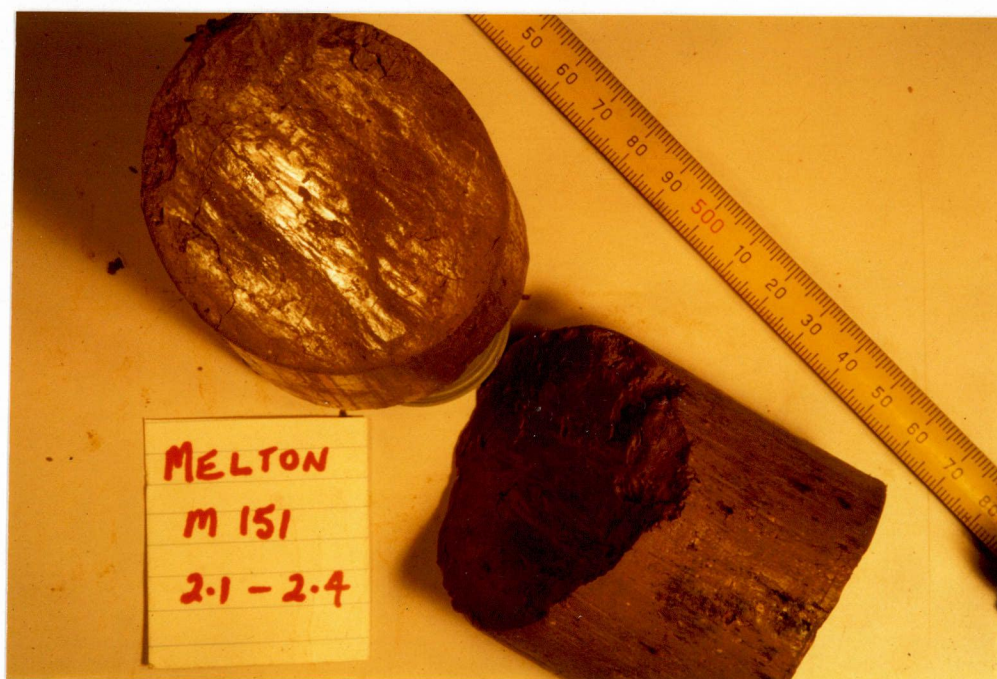
The expansiveness of the clay fraction is displayed by extensive surface cracking in areas where the sands and silts do not overlie the clayey soils (Plate 1). In the profile (as seen from backhoe excavations and core recovered from drilling) the presence of numerous fissures, some filled with sand and others with slickenslided surfaces (Plate 2), testify to the depth of cracking. In all bores drilled on site the fissuring extends the full depth of the soil profile (over 9 metres), with small tree rootlets noted following down the fissure planes.

Plate 2 Slickensliding of fissure in soil core.

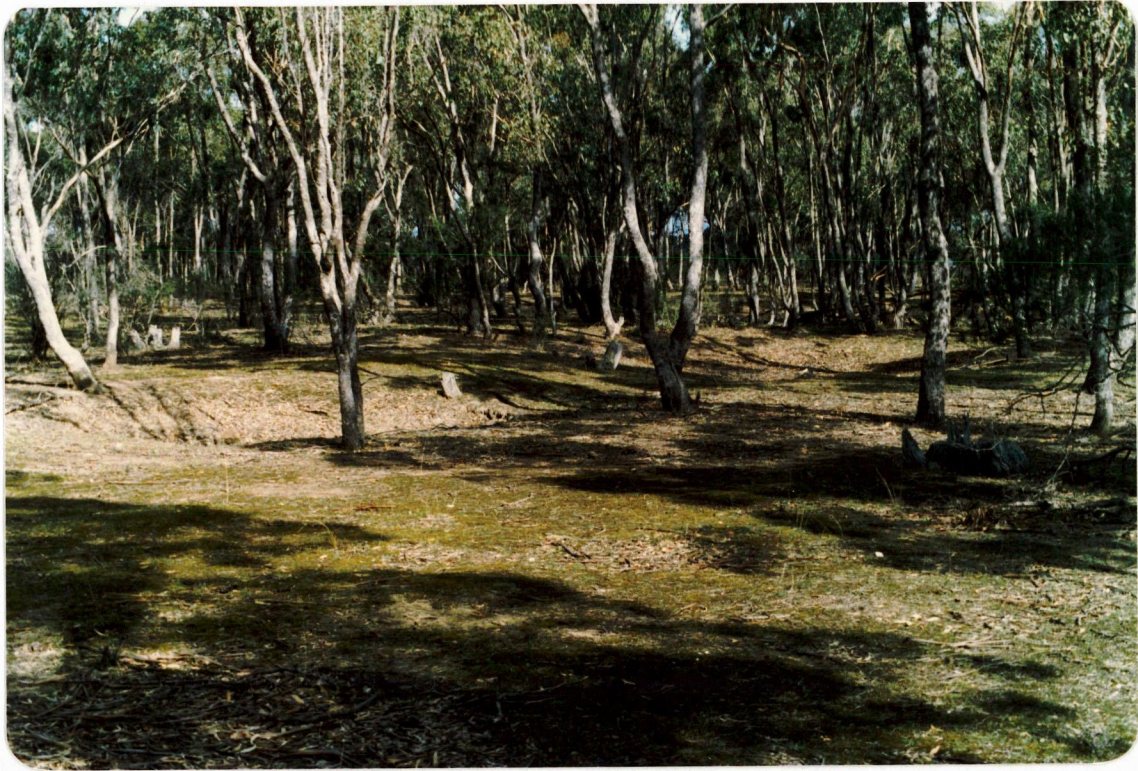
These depressions are generally 2-5 m wide and up to 10 m long. They have no sharp edges and are from 1-1.5 m deep. Very often they appear to have developed along a line and nearly always have a single crack (15 cm wide and several metres deep) along the bottom. The soil in the depression is darker than the surrounding soil since it is rich in organic matter. (Plates 3 & 4).

Plate 3 Broad saucer shaped depressions

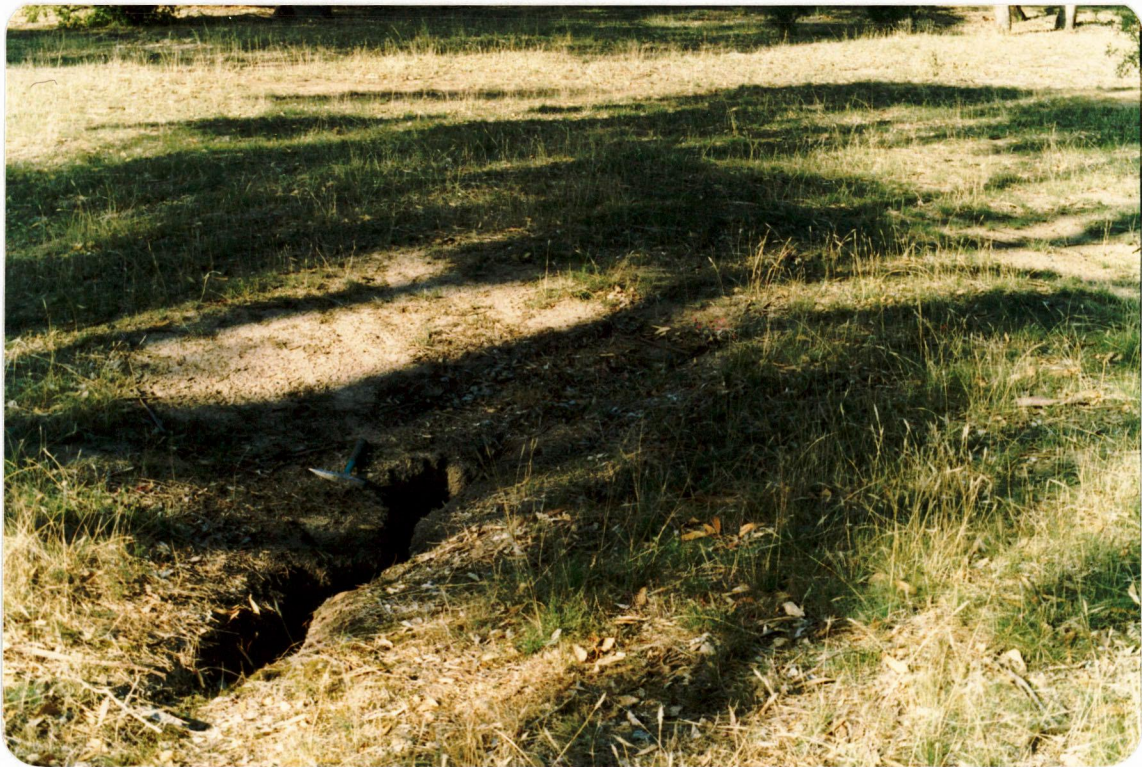
Plate 4 Broad depression with deep cracking

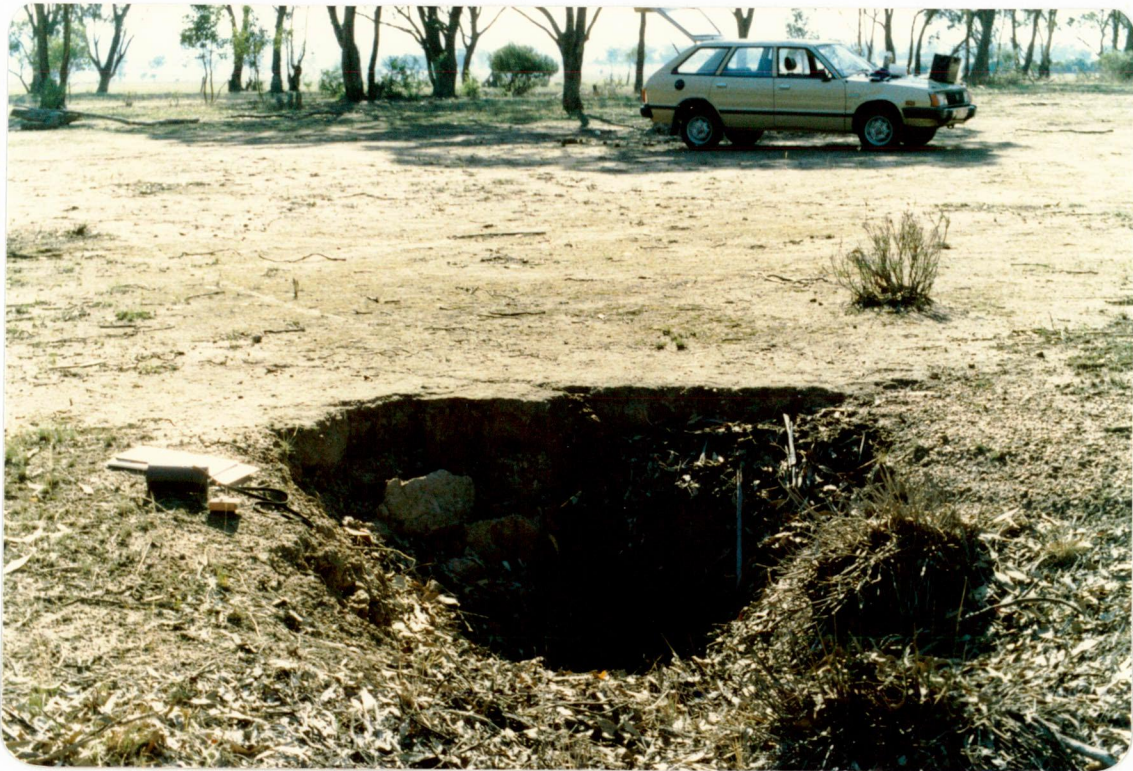
These depressions are similar to those described above, except that they have a sharp drop at the edge on one side of the depression. The drop is typically 0.5-1.5 m or so, and located above the crack in the bottom of the depression. The depression grows larger by erosion of the sharp edge into the centre crack. (Plates 5 & 6).

Plate 5 Sharp edge of depression

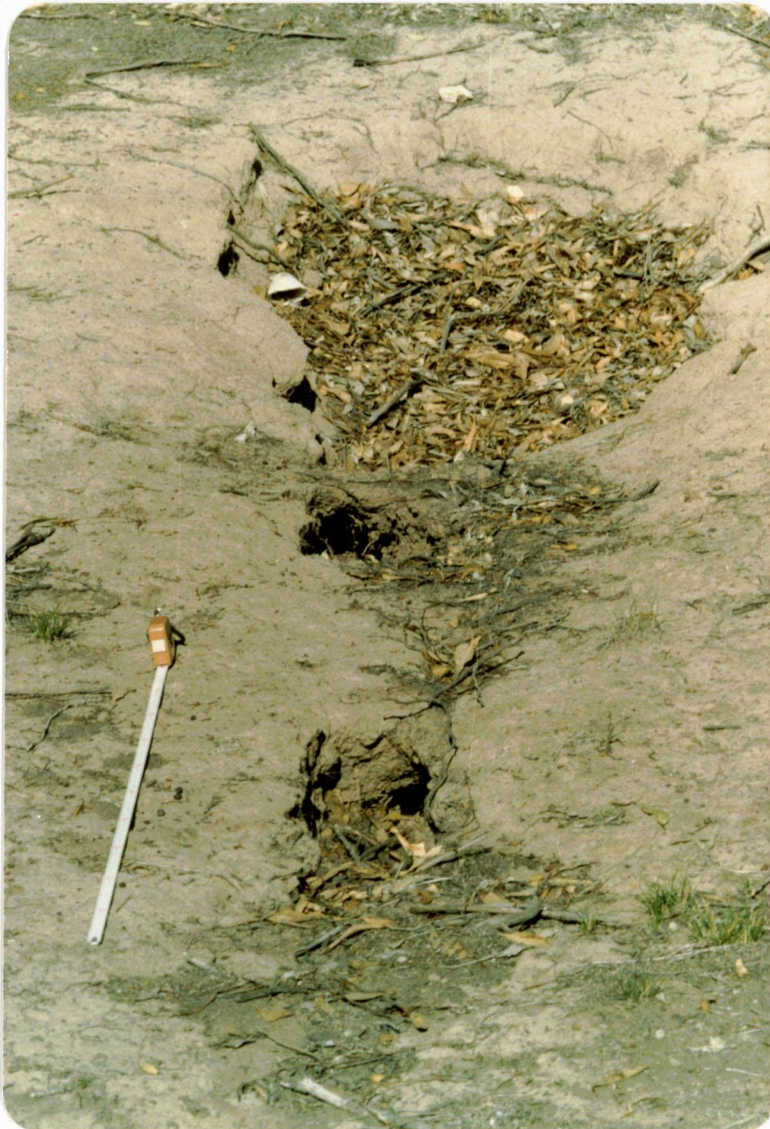
Plate 6  
Depression with sharp edge  
eroding into centre crack

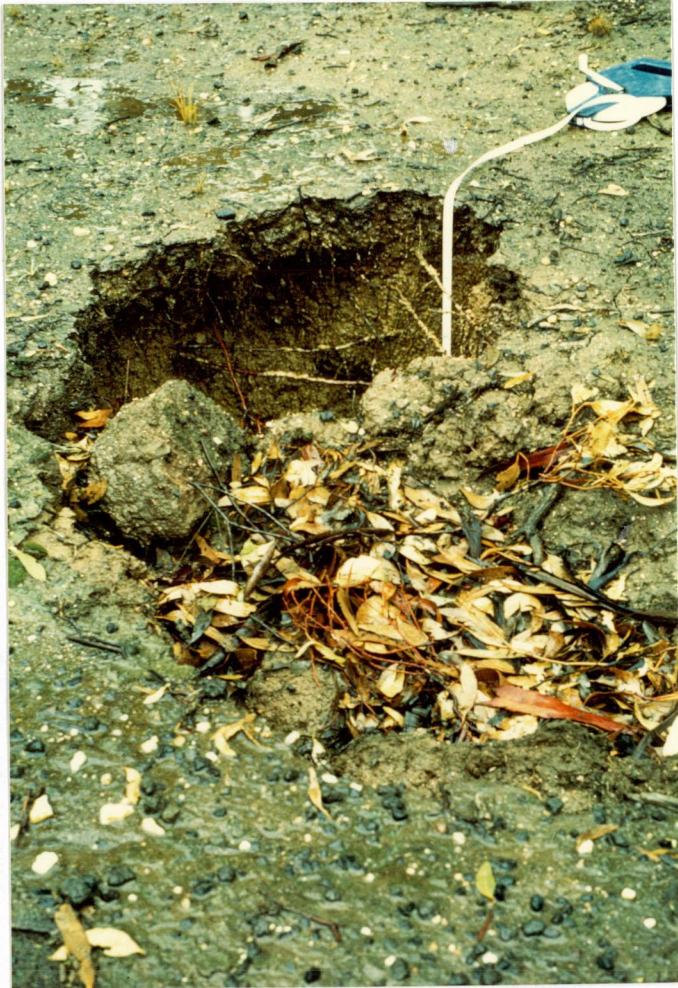
The "sinkholes" are essentially circular depressions occurring on either flat ground or in the bottom of the saucer shaped depressions. They are generally less than 2 m wide and sharp edged. They have been observed to unpredictably develop within a day or so, particularly during or immediately following rain. The depressions are reasonably deep (1.5 m or so) and often have large cracks in the soil at their base. (Plates 7 & 8).

Plate 7 'Sinkhole'  
(photographed in road reserve, Spring 1983)

The most obvious problem for development of the site is the active subsidence. Roads, housing, and sewerage systems would be seriously damaged by sinkhole development. The unpredictability of the sinkholes makes the siting of any structures hazardous. It is likely however, that areas of the site could be found where the potential for subsidence would be lower.

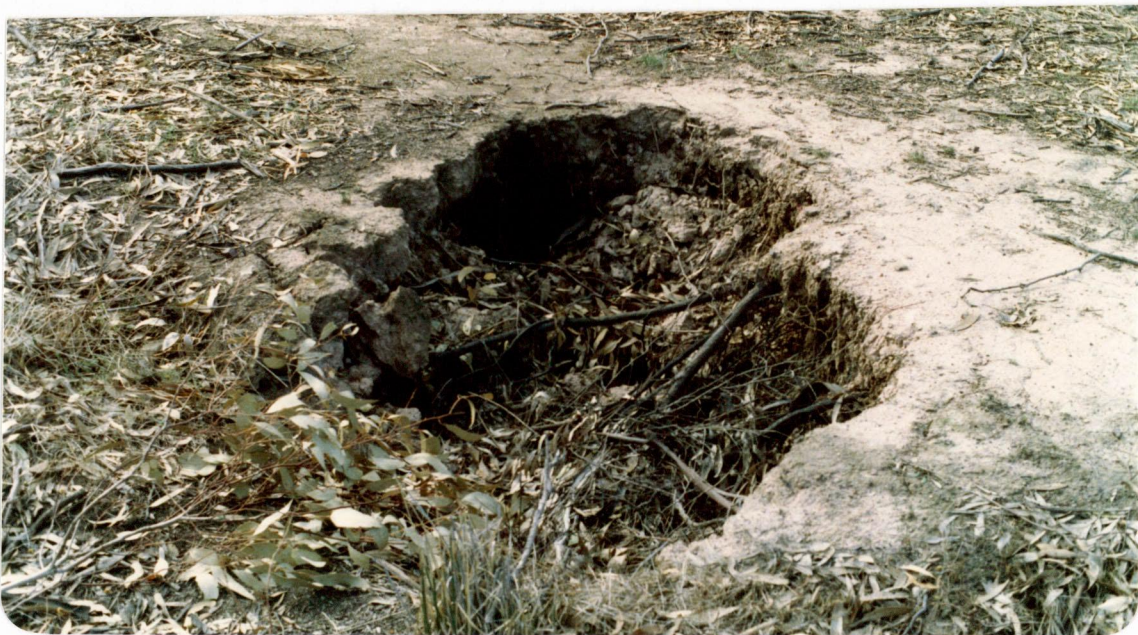
Plate 8 'Sinkhole'  
(photographed on-site 30/4/'85)

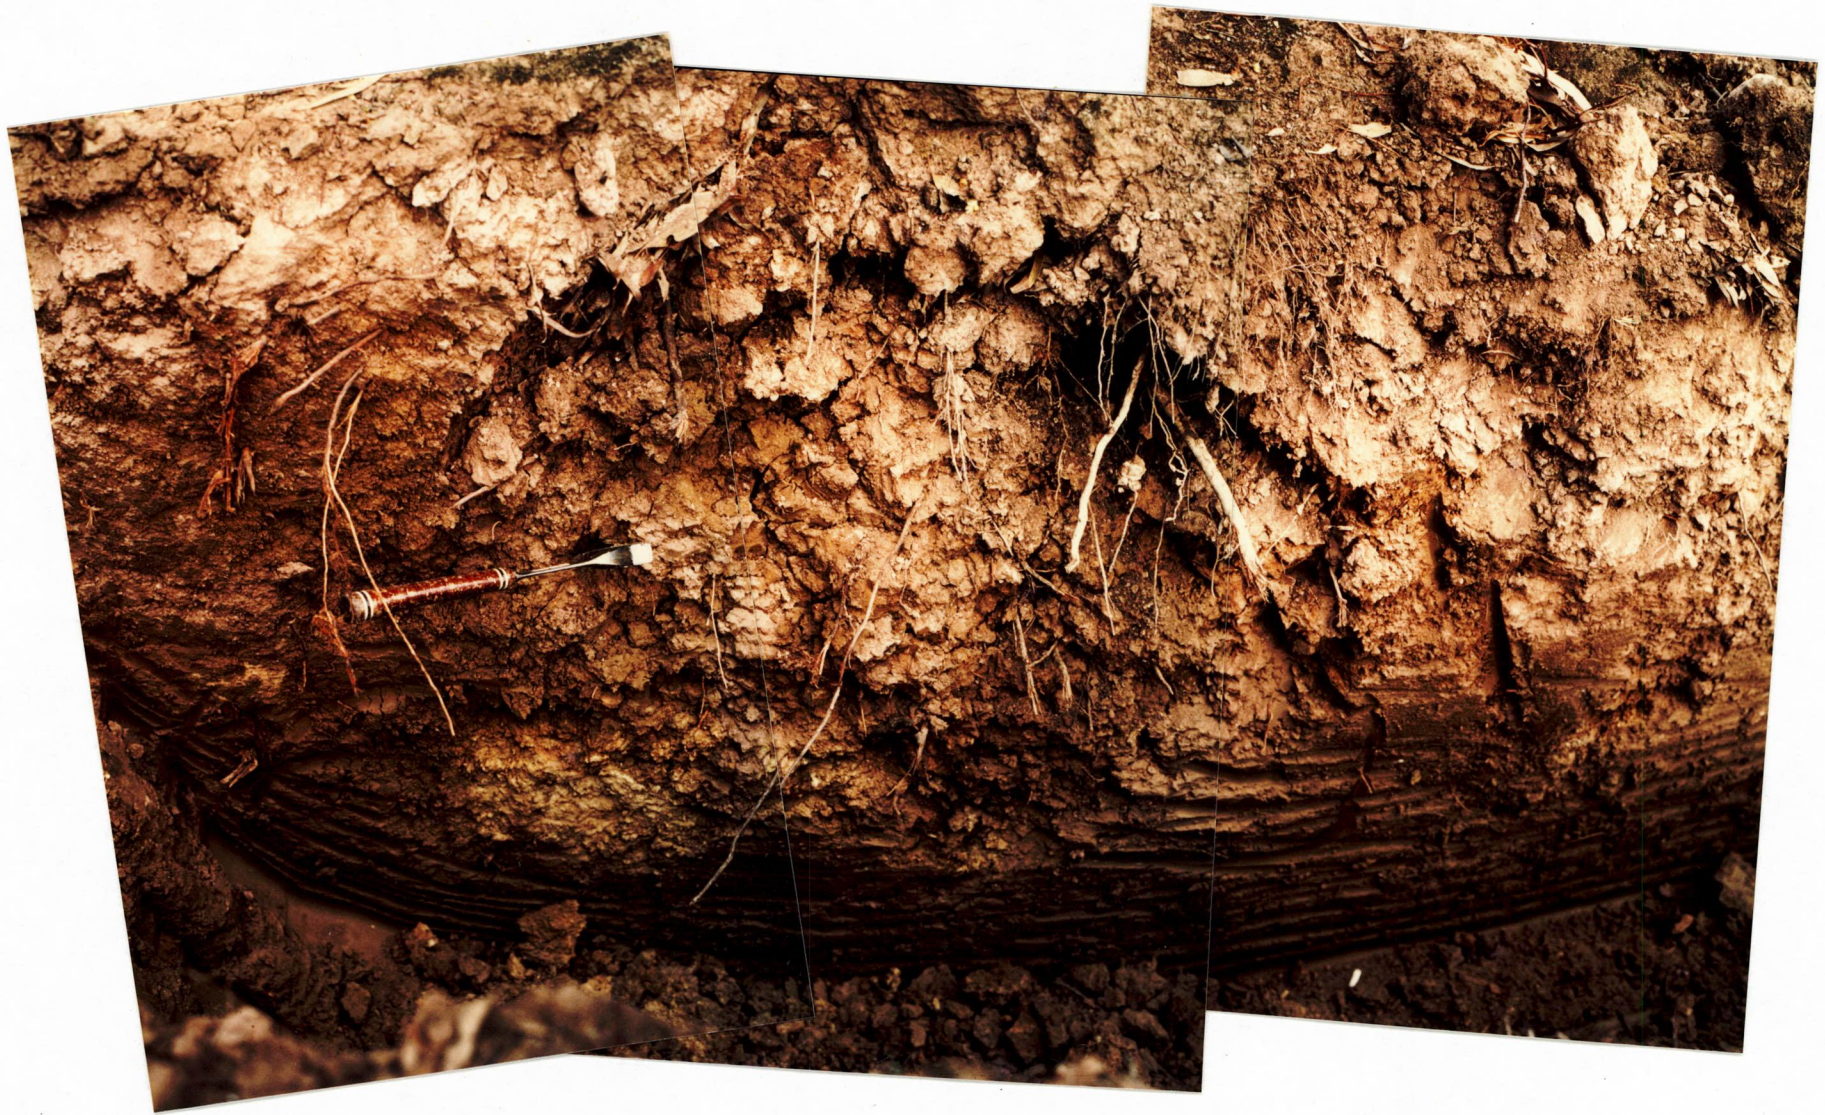
Plate 9      Section through 'skinhole'  
(excavation pit-Djerriwarrh 176 - 10/5/'84)

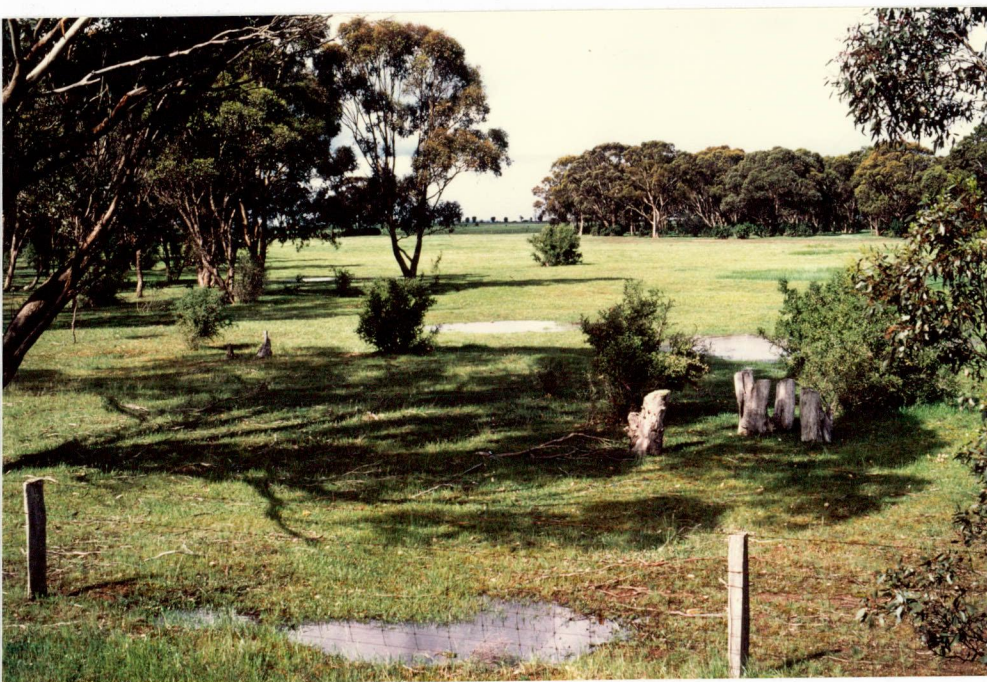
Plate 10 Water filled depressions (Spring 1983)
